# Using a Hydroconductive Dressing to Improve Healing in Complex Surgical Wounds

**Sue Johnson:** Lead Nurse Wound Care, Doncaster and Bassetlaw Hospitals NHS Foundation Trust, Doncaster UK. **Pam Spruce:** Clinical Director TVRE Consulting, Stoke-on-Trent UK.

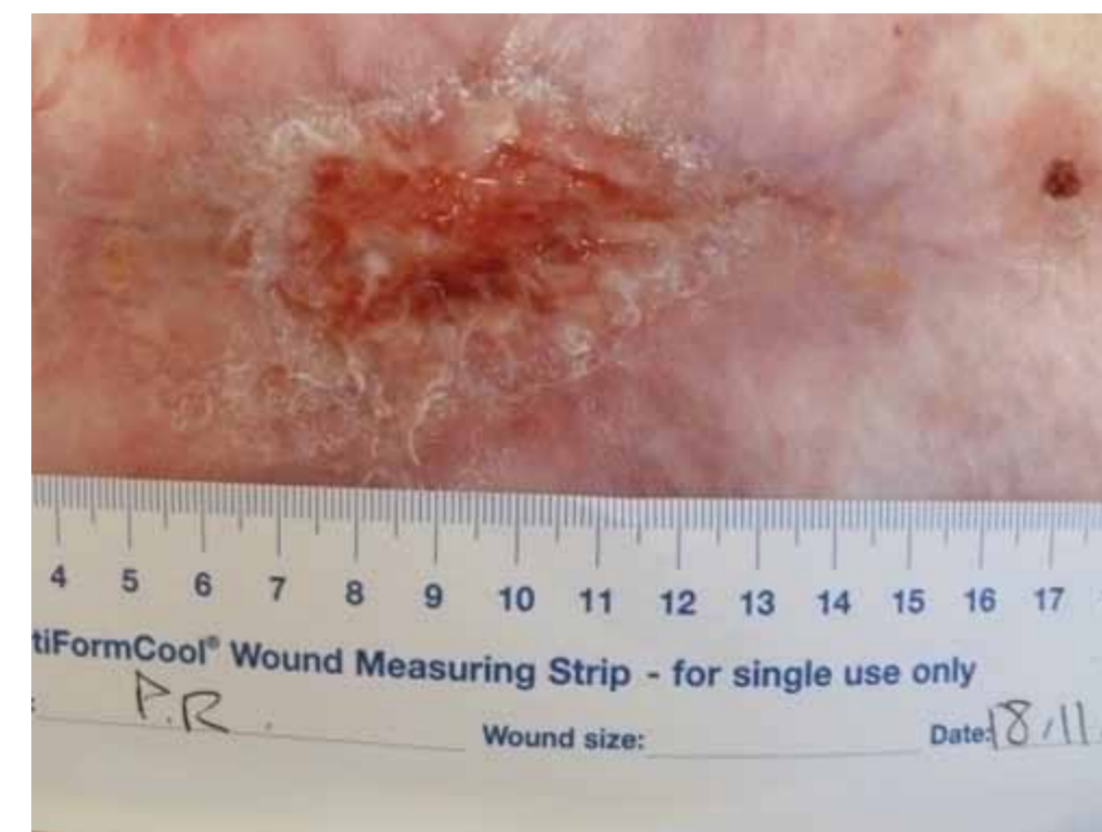
Day 0

On assessment the patient had no pain in the wound, which had a moderate level of exudate. The condition of the surrounding skin was recorded as "fragile".

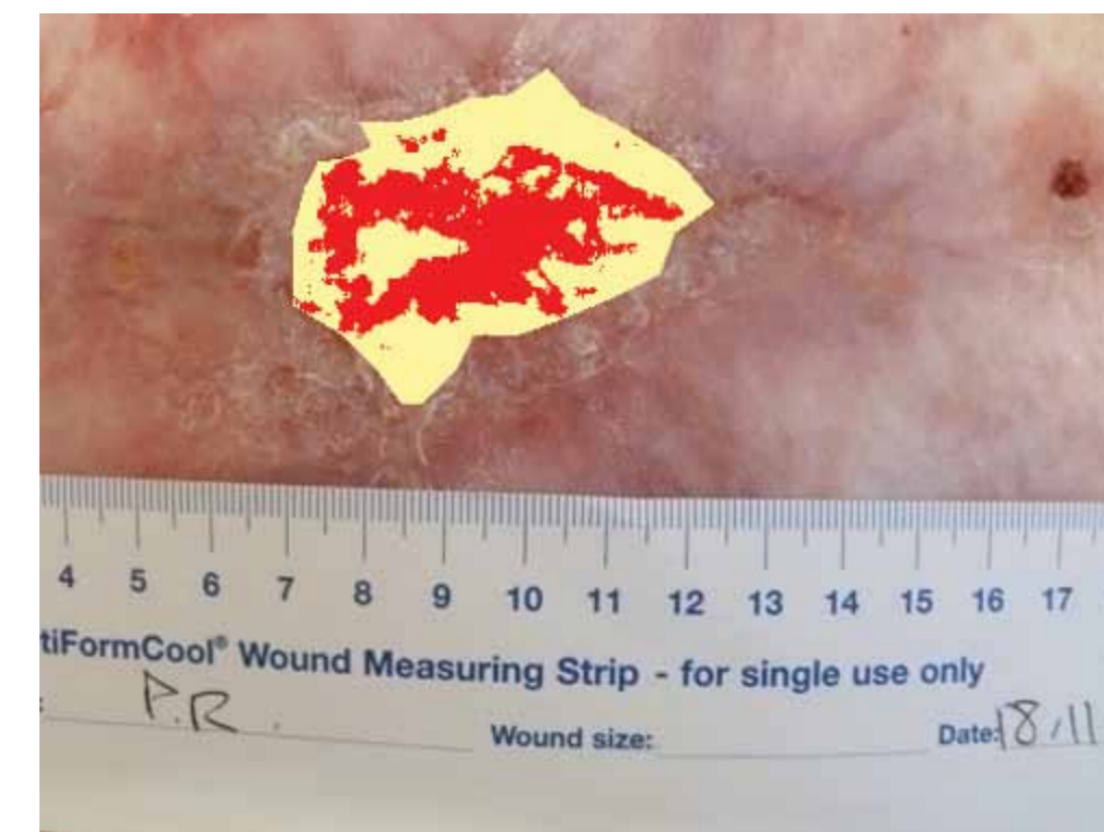
Day 0 Analysis

The progress of each patient was monitored using an advanced wound management software technology\*\* to provide measurements and tissue analysis from the digital images taken as part of the evaluation process.

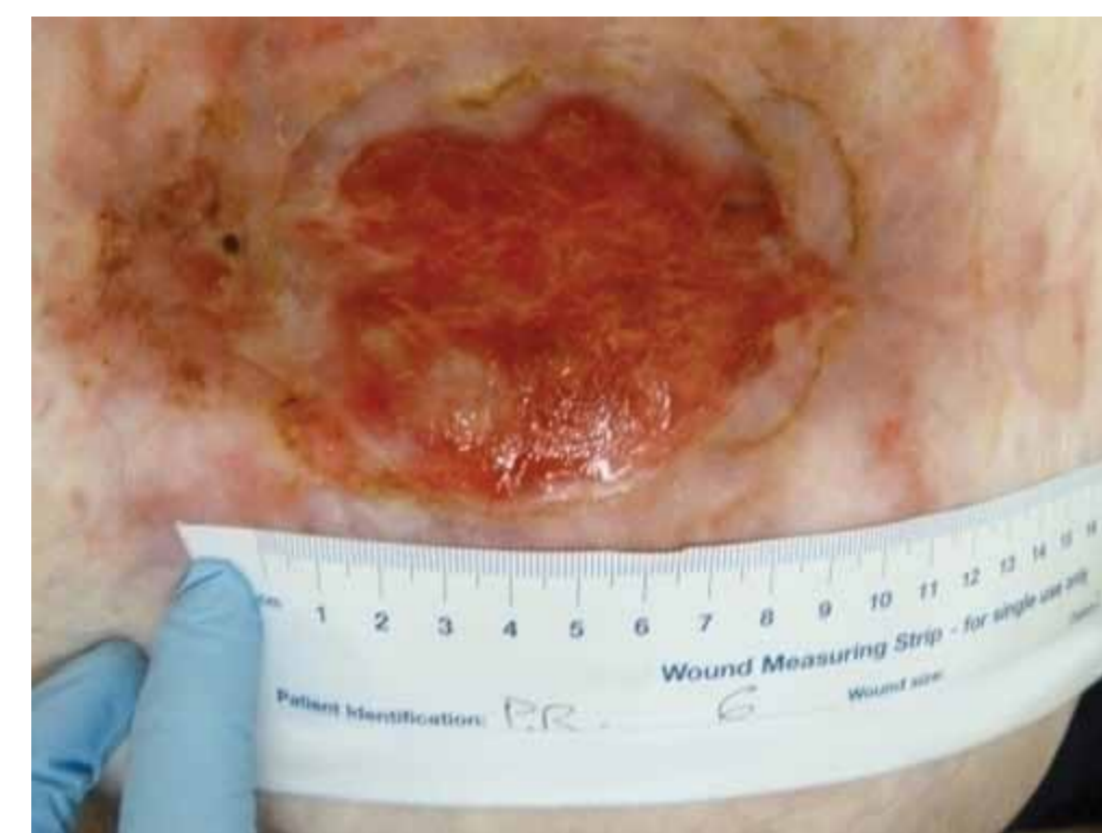
Day 14

The evaluation dressing was applied and by day 14 there was a 44% increase in granulation tissue in the wound bed. The peri-wound tissue was now recorded as "healthy"

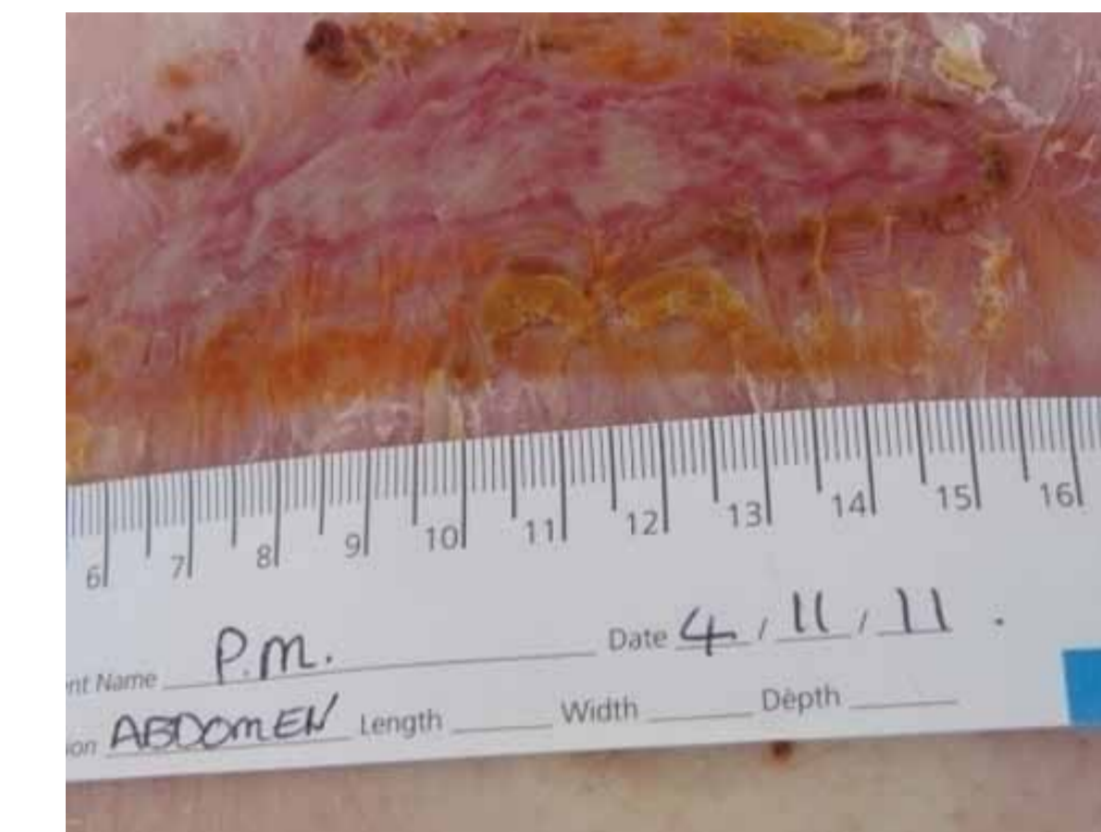
Day 0

The patient was taking analgesia regularly, so at assessment was pain free. There was a moderate level of exudate from the wound. The surrounding skin was healthy, although the wound margins were not clearly defined because of the presence of unhealthy tissue.

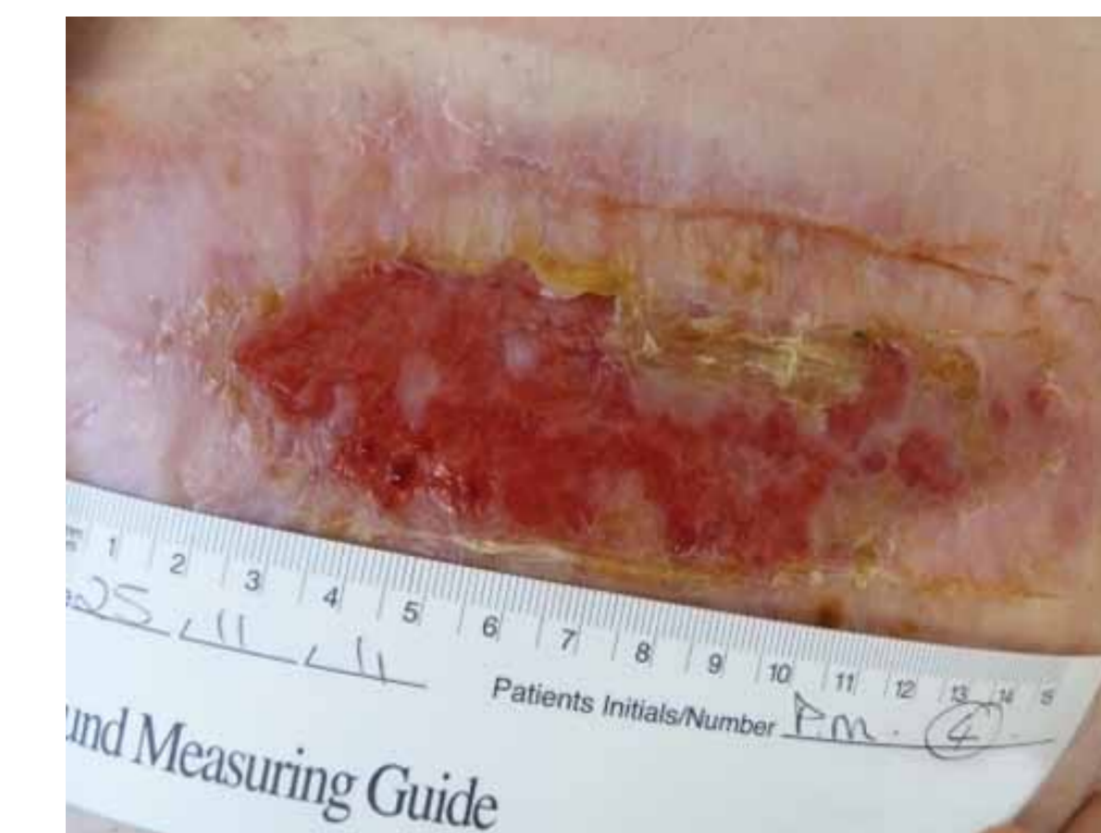
Day 21

The evaluation dressing was applied and by day 7 the healthy granulation tissue in the wound bed had increased by 30.8%, progressing to 94.7% by day 21. At this point the patient was pain free without analgesia.
